A DEMONSTRATION PROJECT BY

The Regional Municipality of Niagara

CRACK AND SEAT NIAGARA ROAD 1 (DOMINION
Town of Fort Erie

in co-operation with the
Ministry of Transportation of Ontario

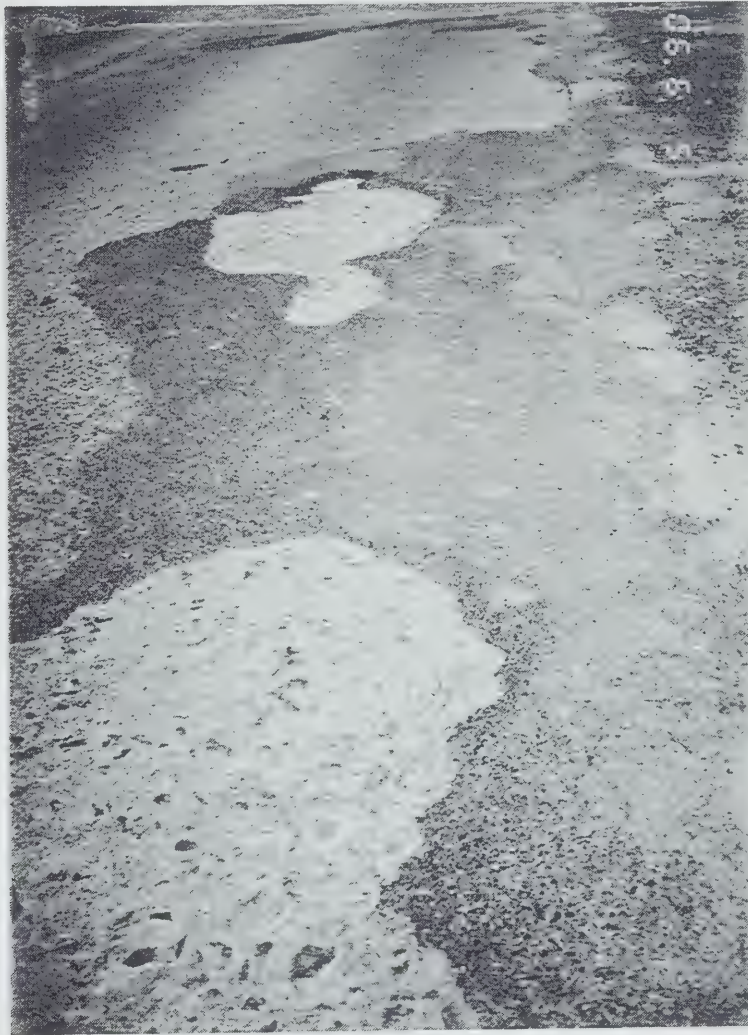
The asphalt overlay of the concrete pavement varied from a thin layer of surface treatment to several inches of hot mix overlay. In some areas, the concrete roadway was visible where the surface treatment had worn. (P5)

P5 EXPOSED CONCRETE AT SURFACE TREATMENT

Initially, some consideration was given to attempting the crack and seating operation without removing the thin overlay of surface treatment. However, leaving the overlay in place would prevent a thorough inspection of the underlying concrete pavement and could possibly act as a shock absorber during the cracking process and, therefore, it was decided to remove all asphalt overlays completely. (P6)

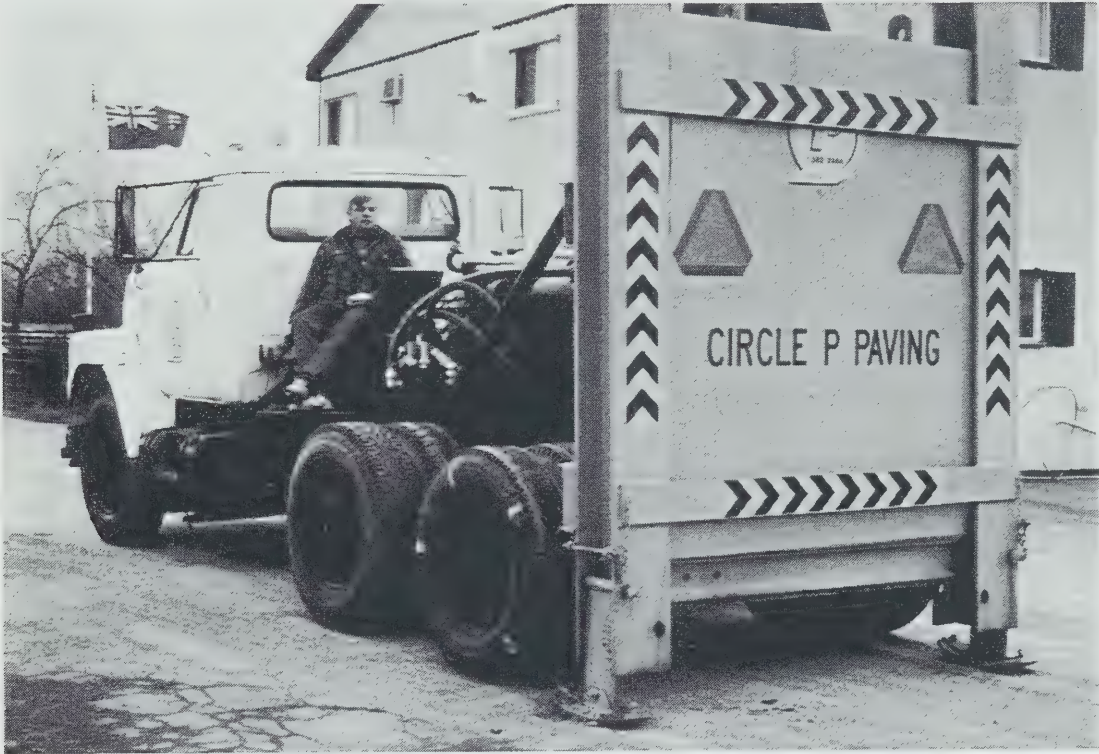
The cracking operation was carried out using a guillotine hammer type breaker (P9) mounted on the rear of a International cab and chassis. The guillotine hammer measured approximately two metres in width and weighted approximately eight tonnes. The striking face of the hammer was constructed out of a piece of railroad steel measuring approximately 7.5 centimetres (3 inches) across the face. On to this 2.5 centimetre (1 inch) square iron bar was welded to concentrate the impact on the concrete pavement. (P10)

P9 GUILLOTINE HAMMER-TYPE BREAKER

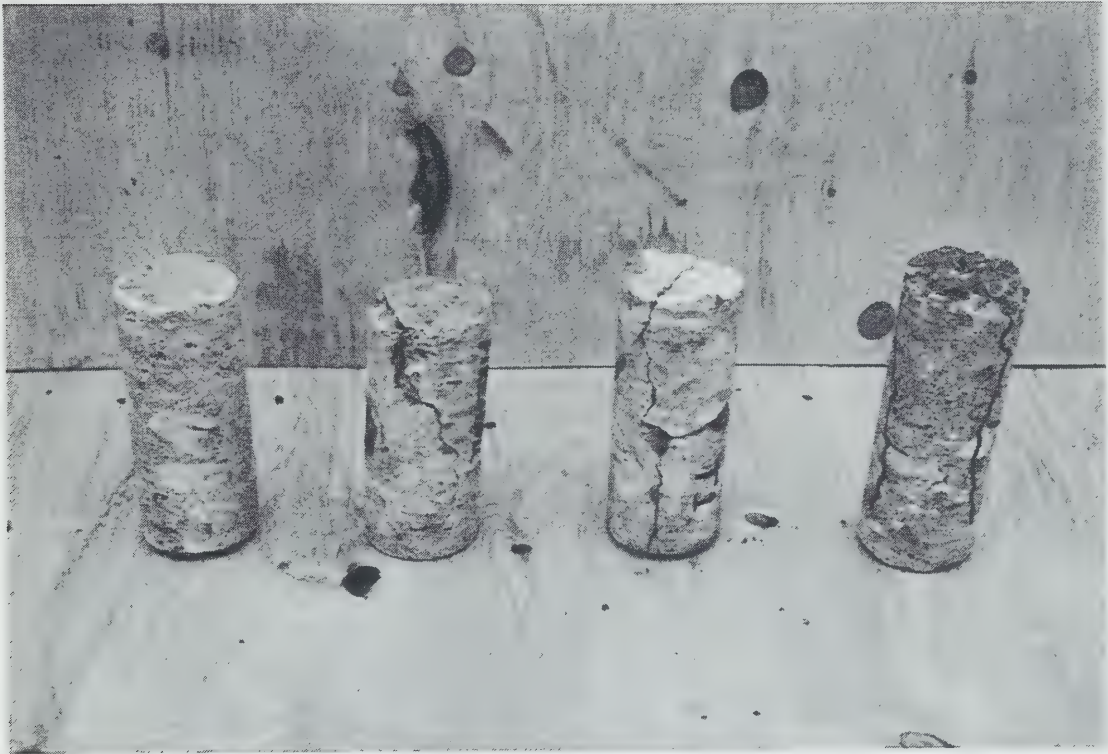
P13 CORE SAMPLES ILLUSTRATE EXTENT OF CRACKING
(SAMPLE B ILLUSTRATES UNDESIRABLE LATERAL CRACKING)
